# Manhole Inspection Summary

Manhole # S37CC1008MH

Insp Date: **12/11/06 11:33 AM**

**Location** Address: **601 37TH ST**

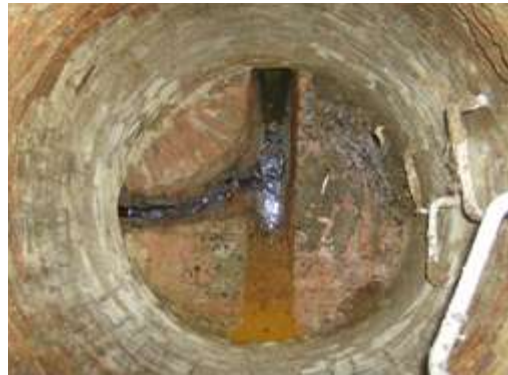
Top View

Corroded steps. Evidence of surcharge - Bench debris. Channel debris.

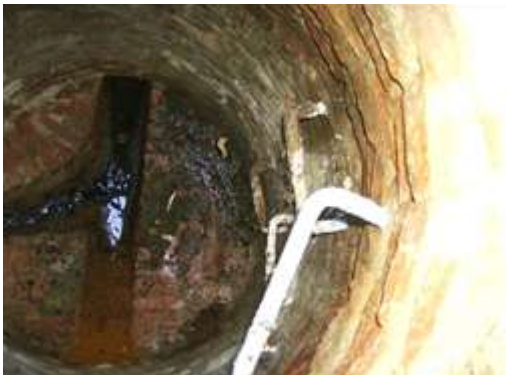
Defect

**Corbel** Material: **Brick** ☐ Parged Type: **Concentric/Eccentric**  
Condition: ☒ Sound ☐ Cracked ☐ Root Intrusion ☐ Loose Brick ☐ Deteriorated  
Infiltration: ☐ None ☐ Joint ☐ Cracks ☐ Mortar ☐ Roots ☒ **Wall**

**Barrel** Material: **Brick** ☐ Parged  
Shape: **Circular** Diameter: **46** (in.) Length: (in.)  
Condition: ☒ Sound ☐ Cracked ☐ Root Intrusion ☐ Loose Brick ☐ Deteriorated  
Infiltration: ☐ None ☐ Joint ☐ Cracks ☐ Mortar ☐ Roots ☒ **Wall**

Corbel and Barrel infiltration.

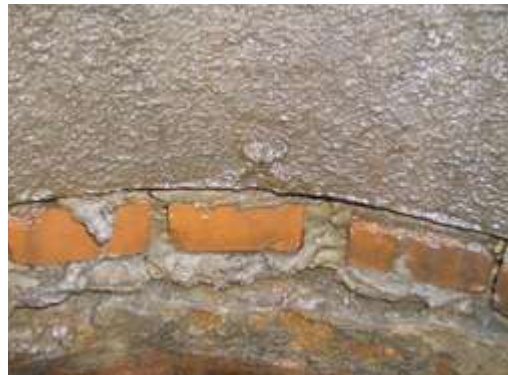
Defect

**Frame** Offset: **0** (in.) Condition: ☐ Sound ☐ Cracked ☒ **Leaks**

**Chimney / Frame Adjustment** ☒ Exists Material: **Brick** ☐ Parged Height: **6** (in.)  
Condition: ☐ Sound ☐ Cracked ☐ Root Intrusion ☐ Loose Brick ☒ **Deteriorated**  
Infiltration: ☐ None ☒ **Joint** ☐ Cracks ☐ Mortar ☐ Roots ☒ **Wall**

Frame leaks. Adjustment deterioration and infiltration.

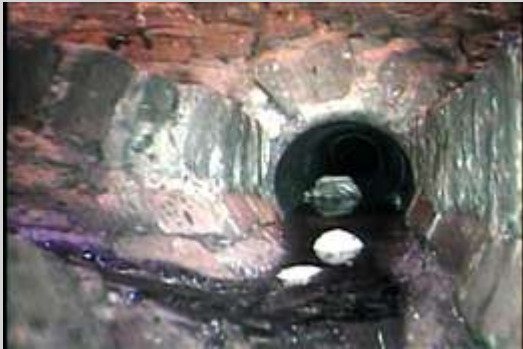
### 8 in. Circular Gravity Sewer Pipe Out @ 12 O'Clock

Deposits: ☐ None ☐ Mud ☐ Sludge ☒ **Debris** ☐ Grease

Silt Depth: **0** (in.) Deposits Extent: **Light**

Infiltration: **Evidence** Pipe Seal Cond: **Unknown**

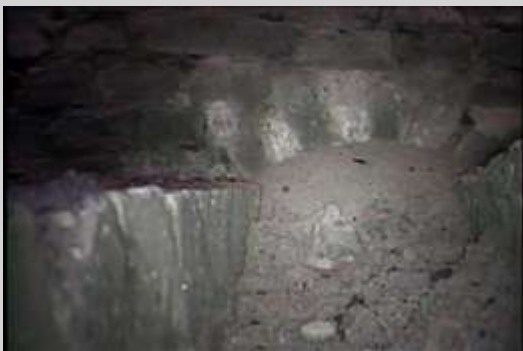
### Pipe In @ 6 O'Clock

Connects To: **Stub connection / abandoned**
